**UNDERWATER FACILITIES
INSPECTIONS
AND
ASSESSMENTS
AT**

**EXPLOSIVE HANDLING WHARF 1
STRATEGIC WEAPONS
FACILITY PACIFIC
BANGOR, WASHINGTON**

FPO-1-82 (01)

JUNE, 1981

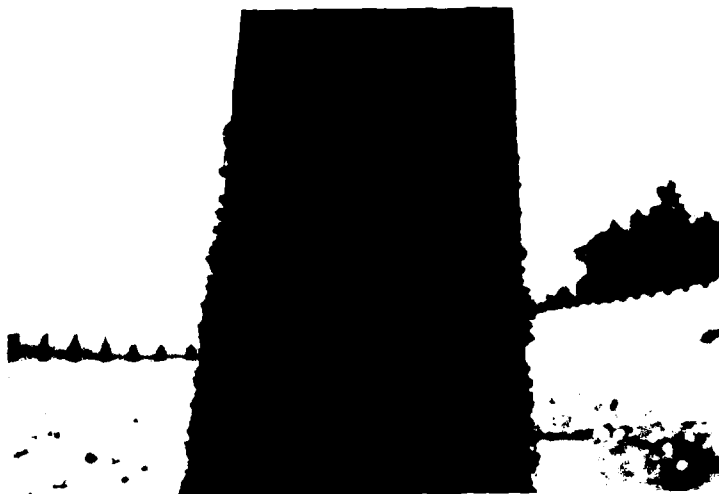
Photograph 20

Several piles were found to have rust marks on the piles following a two or four spot pattern. These were found to be the stubs from the lifting eyes used to handle the concrete piles. In most cases these were not protected and showed signs of rusting, although most topside stubs were properly cut and coated with epoxy (see photographs 18 through 20).

Pile SS-3, Elevation +2.0, South side, showing epoxy coating over lifting eye stubs, as encountered topside.
